Home Inspection Report

9987-999 Ave. NW
Edmonton, Alberta

Job Number: 17747
Property Address: 9987-999 Ave NW
City: Edmonton Province: Alberta
Client Name: John Doe
Client Address:
City: Province: pc:
Phone:
Realtor:

Inspector Name Chris Bottriell
Company Name Alberta Property Inspection Ltd.
Inspection Company Address: Suite #490, 9768 - 170 St. NW
Inspection Company City: Edmonton Province: Alberta pc: T5T-5L4
Inspection Company Phone: 780-486-4412
Inspection Company Email Address: api94@shaw.ca

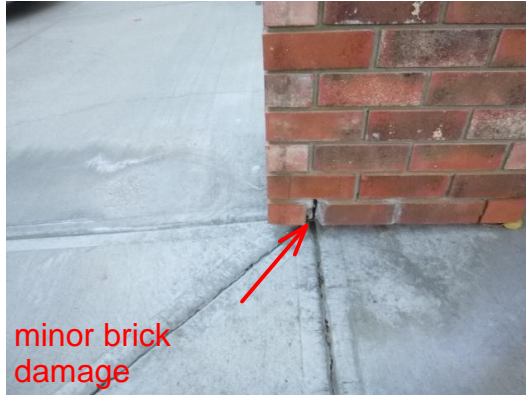
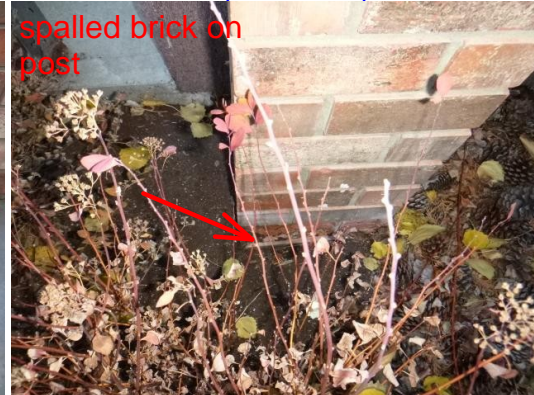
Minor Siding Types: Brick veneer., Vinyl siding: Vinyl siding is durable and relatively maintenance free. Caulking around windows and door frames should be monitored and resealed if gaps develop. Siding should be washed yearly to prevent oxidation. Minor damage to brick on garage, and spalled bricks at post. Remove soil from around brick and add washed stone. Bricks can be repaired or patched.

1. All sides. Exterior Surface Siding Types: Brick veneer., Vinyl siding: Vinyl siding is durable and relatively maintenance free. Caulking around windows and door frames should be monitored and resealed if gaps develop. Siding should be washed yearly to prevent oxidation. [Minor damage to brick on garage, and spalled bricks at post. Remove soil from around brick and add washed stone. Bricks can be repaired or patched.](#)

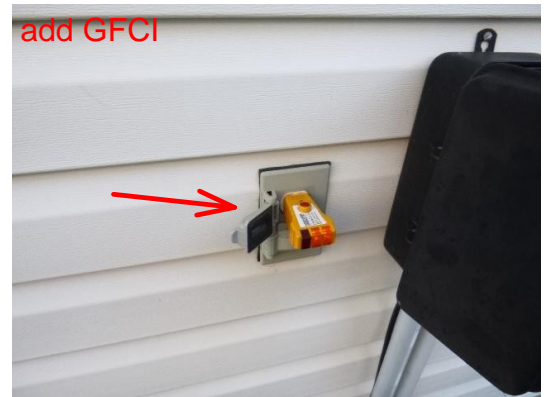
Minor Exterior Electric Outlets: 120 VAC with GFCIs. (ground fault circuit interrupters). Add a GFCI receptacle to west side outside outlet for safety.

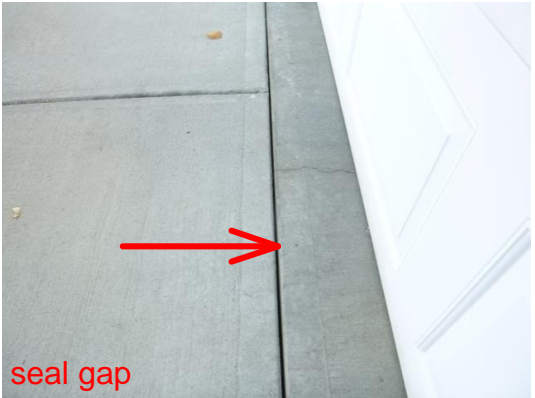
Minor	Driveway Poured concrete. Seal gap between garage pad and driveway. Try Backer Rod and/or polyurethane caulking.

3. Driveway Poured concrete. [Seal gap between garage pad and driveway. Try Backer Rod and/or polyurethane caulking.](#)
4. Hose Bibbs: Frost free hose bibbs. Ensure garden hoses are removed from all frost free hose bibbs before freeze up. Failure to do so could cause basement flooding. [Outside hose bibb does not have an anti-siphon valve. Consider adding for safety available at hardware stores. \(backflow prevention\). Anti-siphon devices protect against a period of low water pressure in the supply line where contaminated water could be sucked back into the potable water supply.](#)

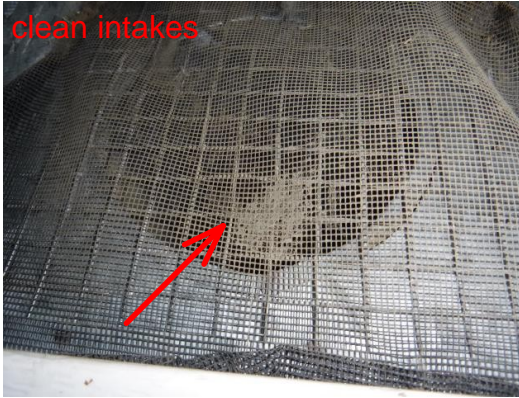
Acceptable	Vent Covers: Metal	
Maintenance	Intakes: Fresh air and combustion air. Clean furnace intake. This will improve interior air quality.

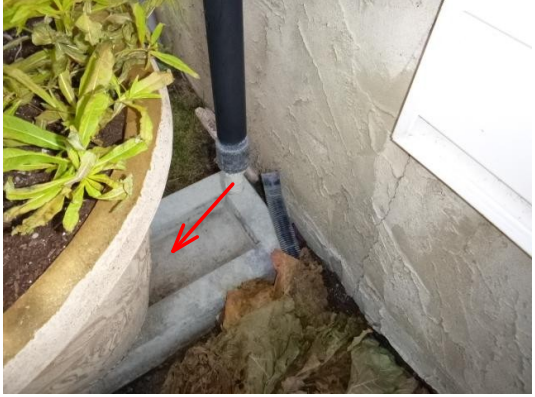
Minor	Sump discharge: Drains over lawn surface. Extend sump discharge pipe to splash pad level. A flex hose can be used in summer but must be removed for winter. A frozen flex hose can cause basement flooding.

5. Sump discharge: Drains over lawn surface. [Extend sump discharge pipe to splash pad level. A flex hose can be used in summer but must be removed for winter. A frozen flex hose can cause basement flooding.](#)

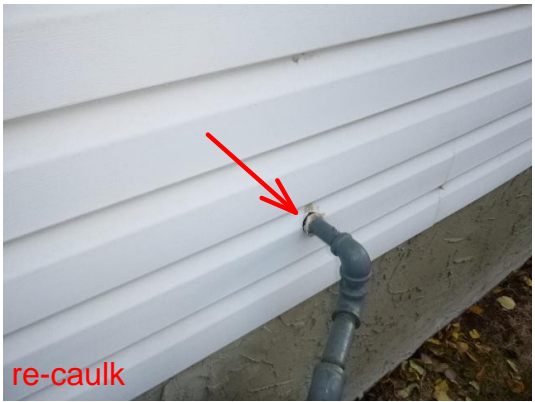
Minor	Gas Meter: Exterior surface mount at side of home. Caulk gasline to siding.

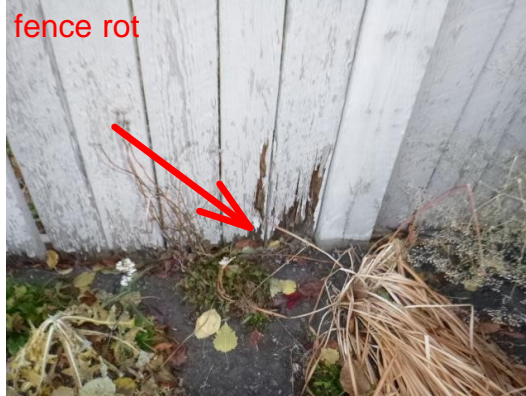
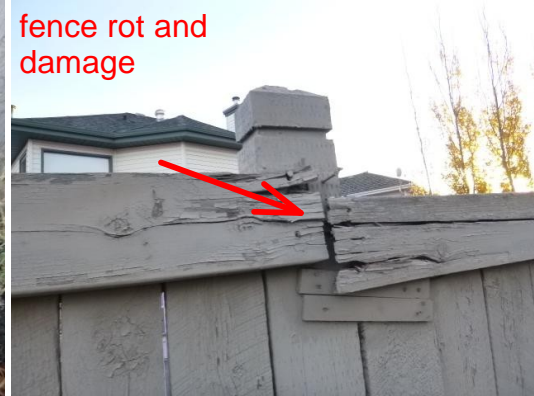
Minor Fence: Wood. Some sections of fence are in poor repair, some rot present, budget to replace along the rear side.

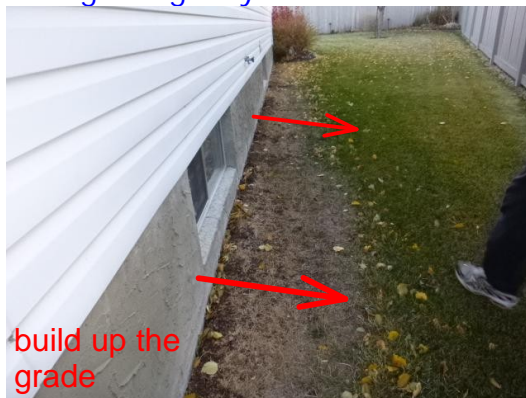
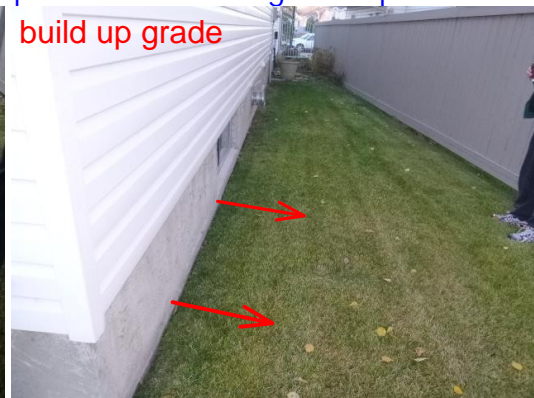
Minor Grading: Earth/stone., Concrete/driveway., Concrete/walk. Settlement and low areas around the foundation should be filled with clay type soil (or soil and a poly sheet) and sloped away from the house. A swale should exist between adjacent properties. Poor grading may contribute to a damp basement among other problems.

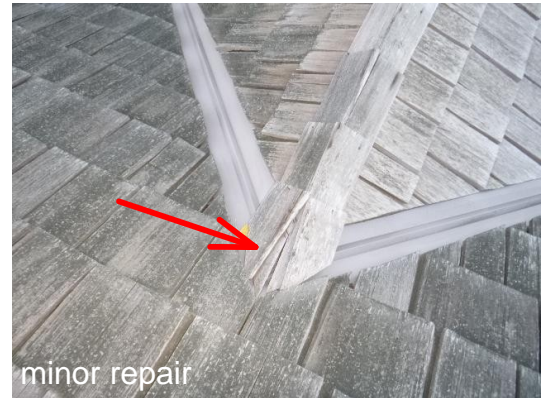
Material: Cedar shake. [Have roofing company re-secure loose ridge shakes.](#)

10. Main Roof Surface Material: Cedar shake. [Have roofing company re-secure loose ridge shakes.](#)

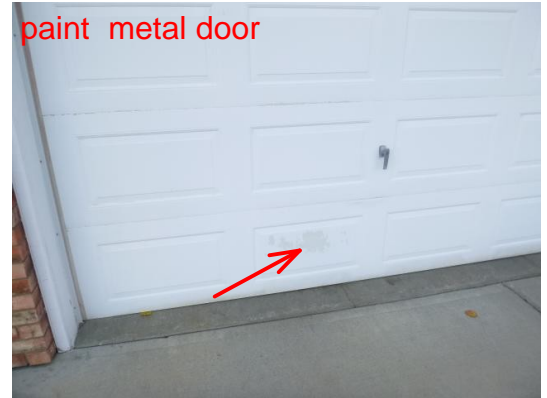
Maintenance Garage Doors: Insulated metal. **Paint touch required overhead door.**

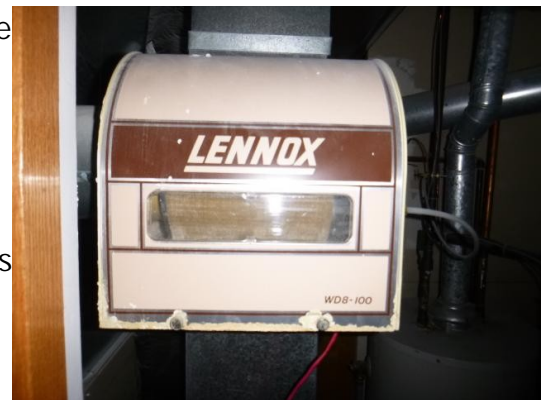
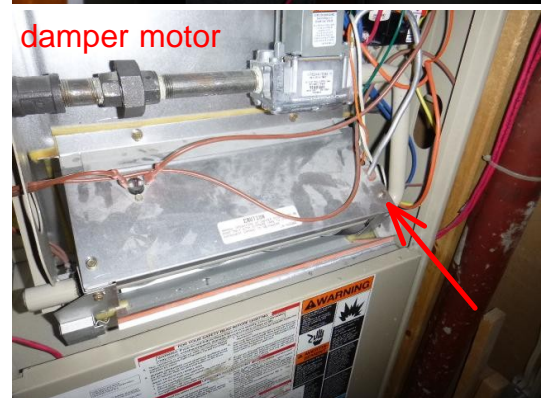
Minor Devices: Electronic ignition, flame sensor, high limit switch. The damper is not functioning properly. This device allows combustion air to enter the combustion chamber. Failure of this device will stop the furnace from starting up. This must be serviced ASAP.

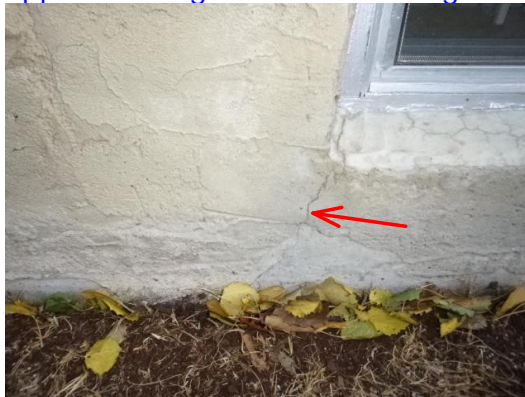
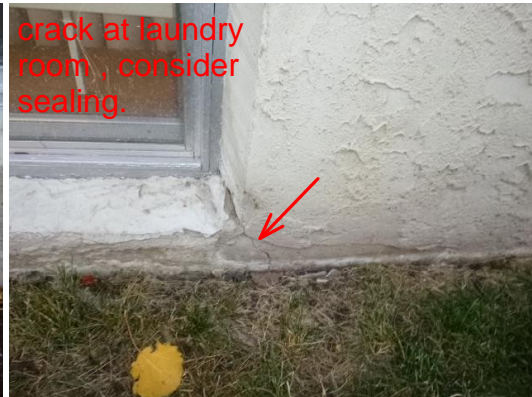
Foundation: The foundation walls are constructed of poured concrete. Rating is based on the visible areas only. Hairline vertical shrinkage cracks are expected. Hairline vertical cracks were noted in the foundation walls at the basement windows. The cracks are likely due to normal shrinkage of the concrete. They should be monitored for seepage which would indicate that waterproofing repairs to the cracks are required. Consider sealing the vertical crack in the laundry room, this crack appears at higher risk of leaking.

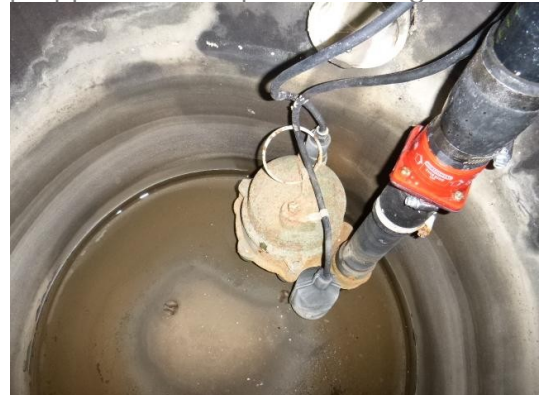
Acceptable	Unable to Inspect: The foundation walls are mostly covered, as a result the condition is not fully known. The foundation walls were viewed wherever possible. Some small cracks are typical and can be sealed if required.
Monitor	Moisture: A Protometer type moisture meter was used in suspect areas of the basement., No visual evidence of water problems in the basement. The basement walls and floors were examined for evidence of water seepage. It is usually not possible to determine the severity and regularity of such problems without monitoring the walls over several months. Most water problems are a result of non functioning eavestroughs, downspouts or poor surface drainage.
Maintenance	Floor Drain: Basement floor by laundry. Flush out floor drain.
Acceptable	Electrical: 120 Volt AC/240 Volt AC.
Acceptable	HVAC Source: Heating system registers.
Recommendation	Sump Pump: A sump system is present in the basement. The pit in the floor is designed to collect water from the foundation weeping tile and then pump that water to the exterior. Pump should be tested seasonally, and pump replaced every 5-7 yrs. Recommend replacing sump pump soon, as pump appears to be past its design life.

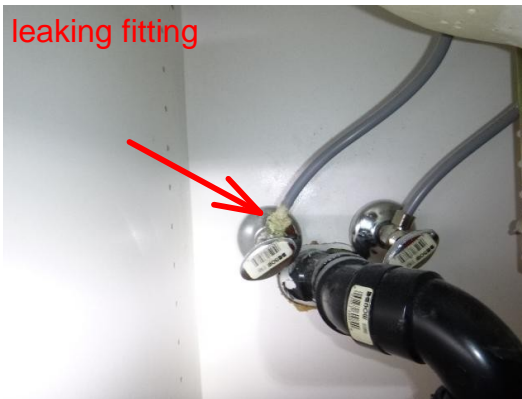
Basement. Bathroom	
Acceptable	Electrical: 120 volt GFCI receptacle
Acceptable	Basin/Vanity: One piece sink/counter top. No overflow.
Minor	Faucets/Traps: Single lever with plastic trap. Leaking supply line at fitting.

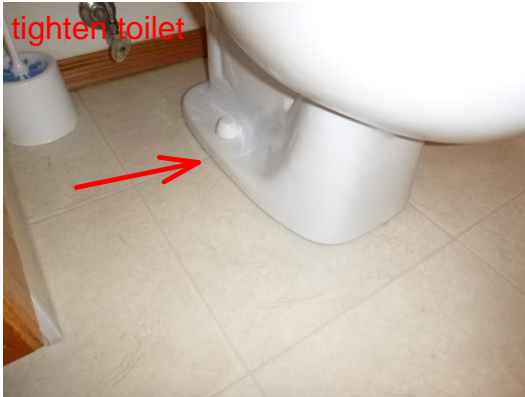
Minor	Toilets: Regular flush - The toilet is loose at the floor and requires tightening.

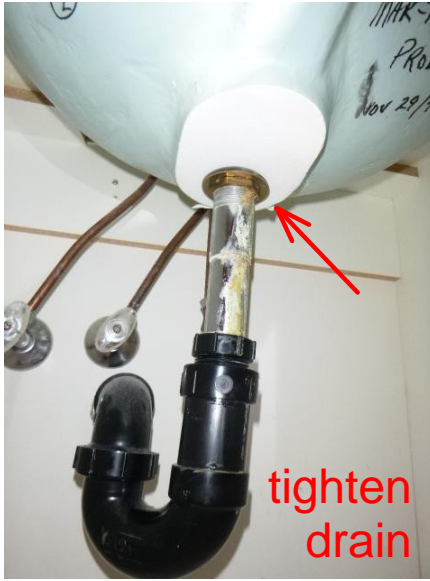
Acceptable	Tub: Tub with tile/ceramilite surround.	
Acceptable	Shower: Operated	
Acceptable	Ventilation: Electric ventilation fan.	
Main Bathroom		
Acceptable	Electrical: 120 volt False face GFCI.	
Minor	Basin/Vanity: Molded single bowl. No overflow drain. Leak stains on drain. Tighten drain fitting.

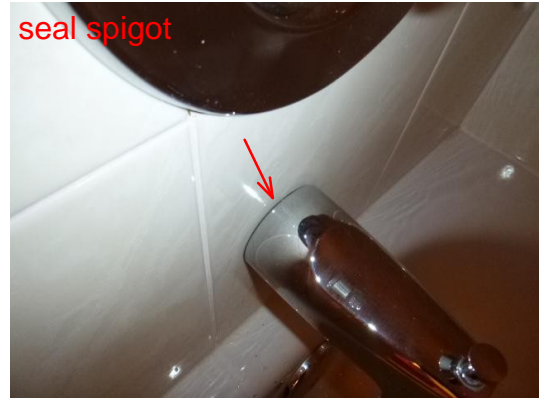
Minor Shower: Operated - Seal between spigot and tub with silicone.

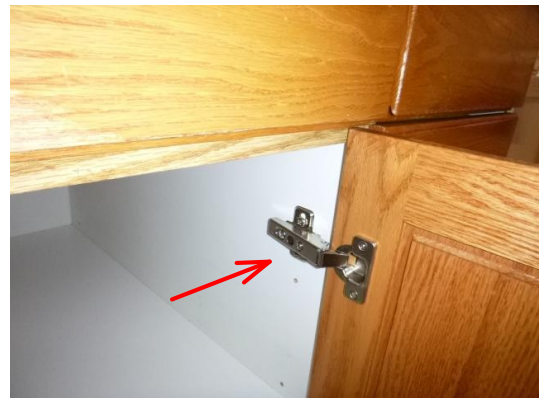
Acceptable	Ventilator: Exhaust fan vents to the exterior through the built in microwave.
Acceptable	Electrical: 120 Volt split receptacles
Acceptable	Plumbing/Fixtures: Single lever, veggie sprayer with plastic trap.
Acceptable	Sink/Trap: Stainless steel double with plastic trap.
Acceptable	Dishwasher: Built in, operated.
Acceptable	Counter Tops: Laminate.
Minor	Cabinets: Wood. Tighten loose hinge hardware.

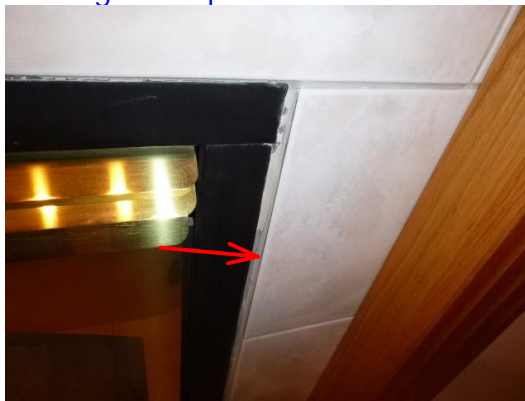
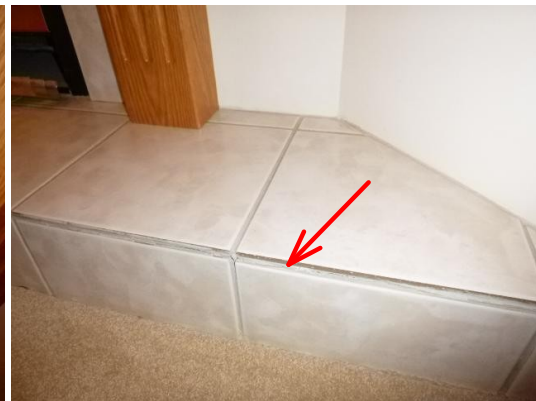
Hearth: Raised tile. [Repair grout around the trim surround, this is a cosmetic repair.](#)
[Minor grout repairs at hearth tile.](#)

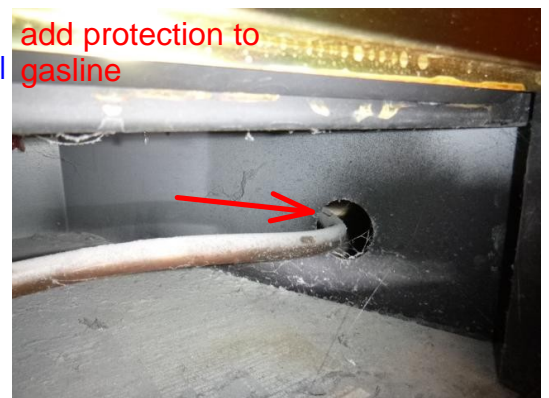
Gas Service Lines: Copper. [Gasline should be protected when passing through fireplace metal casing.](#)

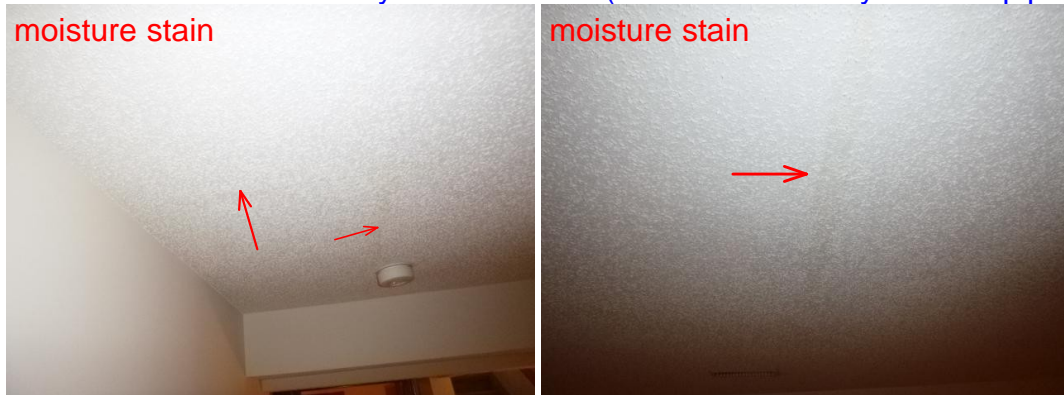
Minor Ceiling Finishes: Texture paint. Water stains were noted in the basement ceiling below the kitchen. The stains were dry during the inspection using a moisture meter, also checked with an infrared camera. Stain should be monitored for further leakage. The source of the leak may still be active. (See notes on Poly B water piping).

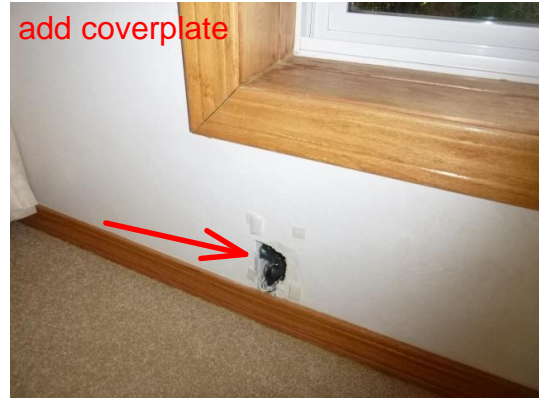
Minor Electrical Fixtures: 120 Volt AC. **Missing outlet/switch coverplate.**

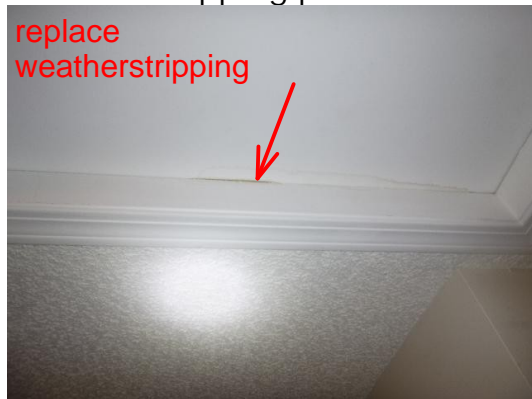
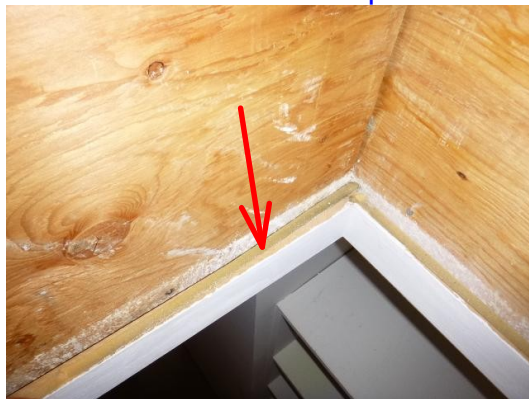
Weatherstripping present for attic hatch cover? Yes : [Improve weatherstripping at the attic hatch.](#)
