Home Inspection Report

9987-999 Ave. NW
Edmonton, Alberta

Job Number: 17747
Property Address: 9987-999 Ave NW
City: Edmonton Province: Alberta
Client Name: John Doe
Client Address:
City: Province: pc:
Phone:
Realtor:

Inspector Name Chris Bottriell
Company Name Alberta Property Inspection Ltd.
Inspection Company Address: Suite #490, 9768 - 170 St. NW
Inspection Company City: Edmonton Province: Alberta pc: T5T-5L4
Inspection Company Phone: 780-486-4412
Inspection Company Email Address: api94@shaw.ca

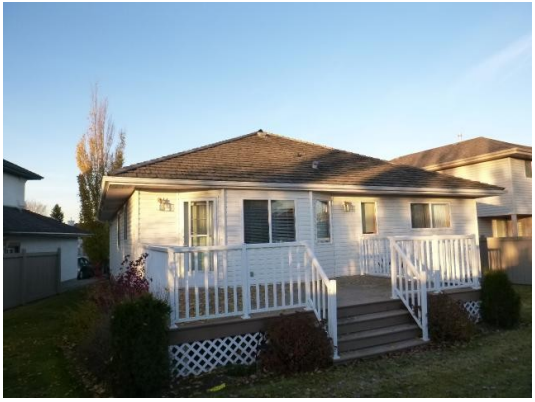
Acceptable Acceptable	Main Gas Valve: Located at the gas meter. Deck: Composite (Maintenance free) with metal railings. Deck is supported on concrete piles.

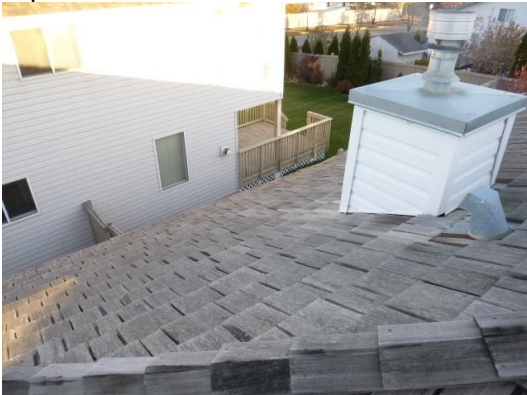
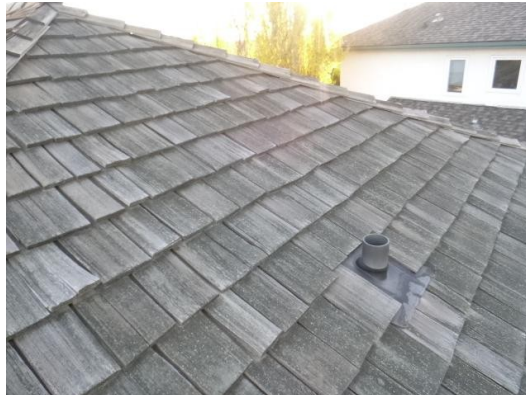
Material: Cedar shake. [Have roofing company re-secure loose ridge shakes.](#)

Cedar shake roofs, common problems with the wood are splitting and rot. Both are due to moisture.

Wood roofs require maintenance every 5 yrs. to 10 yrs. to add missing or dislodged shakes and replace severely cracked ones. Moss or other organic matter should not be allowed to grow on the roof cover as it promotes wood rot.

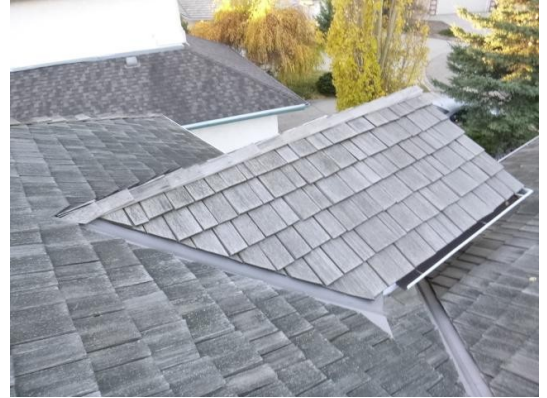
Acceptable Valleys: Preformed metal.

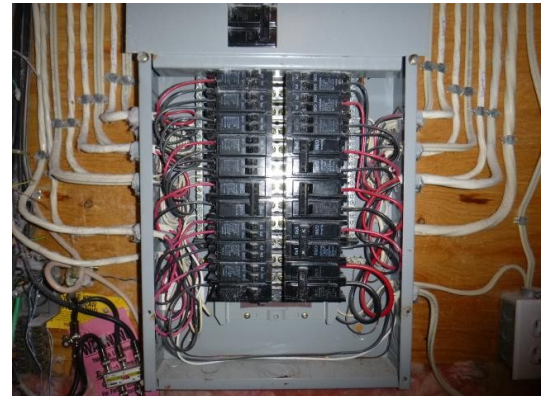
Acceptable	Service: The electrical service to this house is supplied by an underground service conduit.
Acceptable	Conductor Type: Romex and Armored cable -This wiring is modern grounded cable that is equipped with a grounded wire. This wire enables three pronged outlets to be used safely..
Acceptable	Service Conductor: Aluminum.
Acceptable	Service Grounding: Service ground is connected to the service side of the water meter.
Acceptable	Bonding: A static bonding wire is present connecting to gasline.
Acceptable	Service Conduit: Plastic.
The main	panel is located in the basement. Electric Panel
Acceptable	Manufacturer: Commander.

Maximum Capacity: 125 Amps.

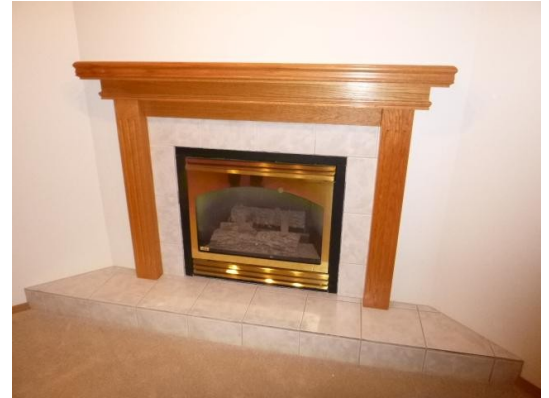
Fireplace Construction: Metal prefabricated.
Fireplace glass should be cleaned on the inside yearly, use Fireplace Glass Cleaner only. Keep area clean under the firebox.

Type: Gas log direct venting with pilot light.

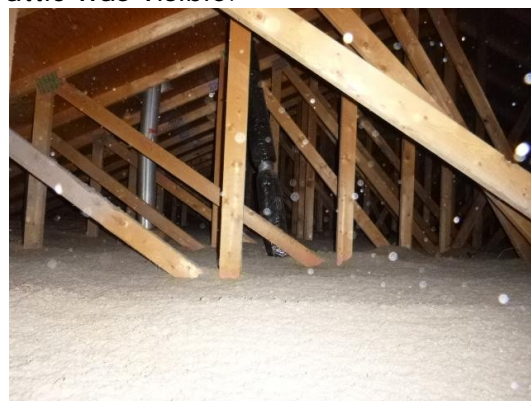
Acceptable Roof Framing: Engineered Truss.

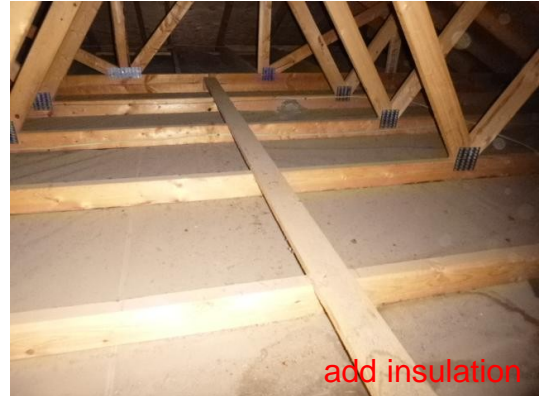
Acceptable Roof Framing: Engineered Truss.
